ELMWOOD PARK FREE PUBLIC LIBRARY

CAPITAL PLAN

January 2012 - December 2016

Executive Summary

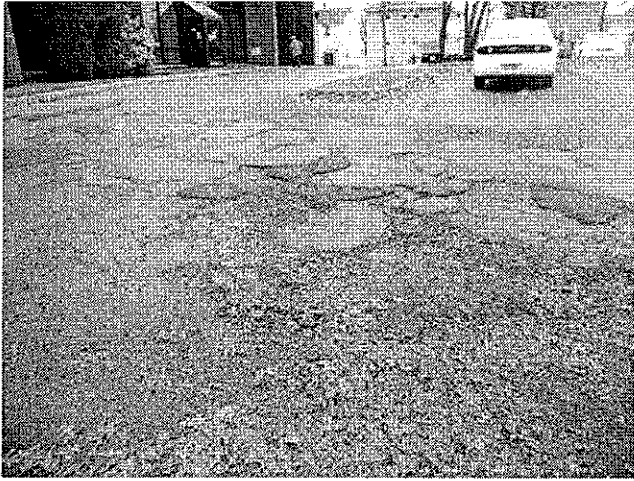
The overall condition of the site is fair. There are numerous locations where tripping hazards occur throughout the asphalt and brick paver areas. The asphalt parking surface has potholes and surface defects (image A1). The parking space striping is worn almost completely away, including the required handicap parking designations (images A4, A5). The lot appears to need milling and a new top layer of paving. It is possible that certain areas where the condition is worse, typically at the catch basins, may need new base layers as well.

A1 _Asphalt Surface Defects

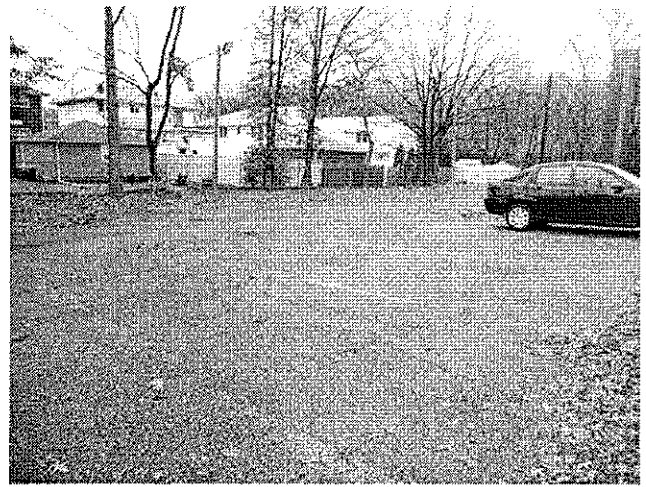
Almost all visitors to the library arrive by car. There are a total of 46 parking spaces that includes 2 accessible spaces and 5 staff spaces. The number of accessible spaces is within the required Code amount but at least one of the spaces must be a van-accessible space. This will require an 8-foot access aisle adjacent to the accessible space. The existing configuration allows for this without loss of additional parking. The line stripping required per the ADA must be applied since the existing lines are nearly completely worn away (image A2).

A2 _Faded Striping

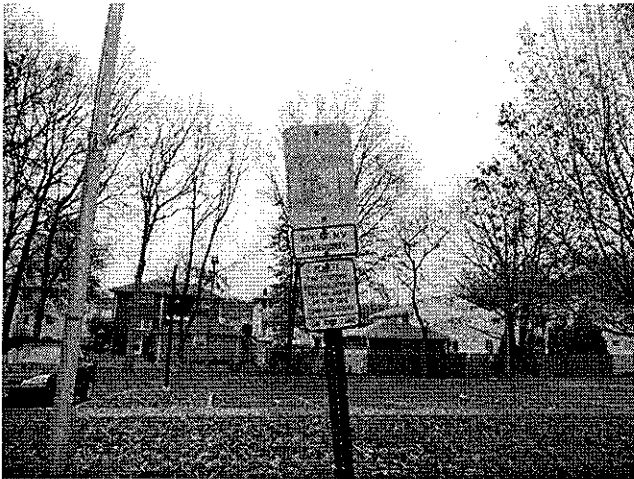
A3 _Faded Handicap Signage

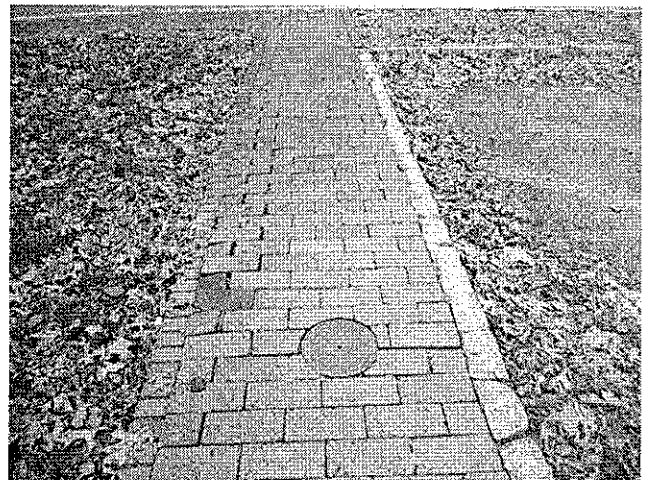
The pedestrian walkways are made of brick pavers that are contained by a curbing of Belgian blocks. Throughout the entire paver area the bricks have settled and are uneven, causing tripping hazards. The block curbing is uneven throughout and can be perceived as a hazard as well (image A6). The brick walkways are sloped due to the property configuration and, when wet or at freezing, can become slippery. All of the brick pavers and the block curbs should be replaced with concrete walks and curbs instead of resetting/reusing those materials.

A6 _Paver Settlement

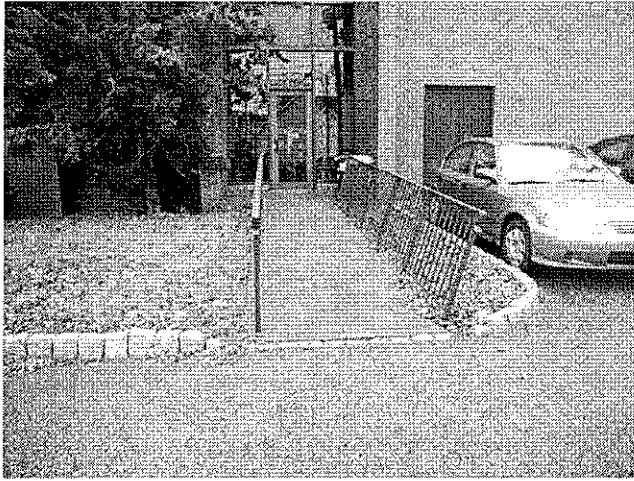
Along the South side there is an emergency exit that appears to be used as a staff entrance. There is a sloped walk that leads from the staff parking to the door. This walk has railings on both sides, one of which is falling over (image A7). The brick pavers near the door have settled and produce a sloped landing, whereas a level landing is required by Code. The rail should be repaired and the walk/ramp replaced with concrete (image A8).

A7 _Falling Railing

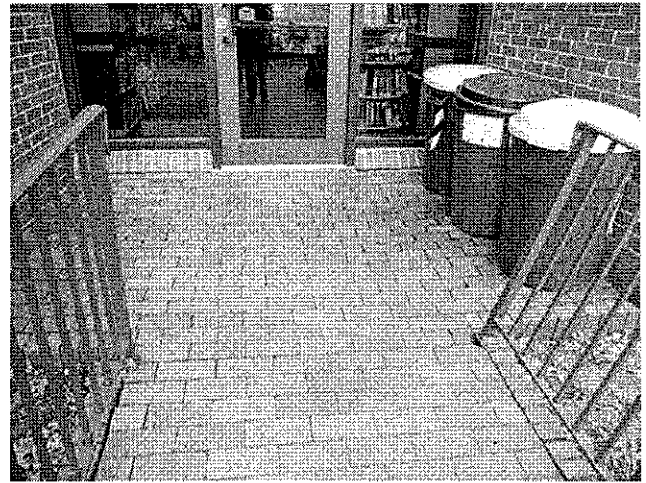
A8 _Sloped Landing

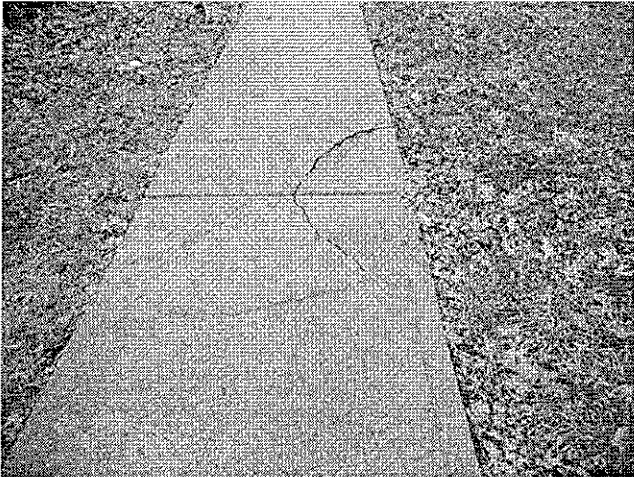
Along the North side the concrete walk that leads to Lee Street at the rear, has one area that is cracked and in need of repair but overall it is in good condition (image A9). This side also has an emergency exit door with a sloped brick walk (image A10). There are benches located in the grass area. These are cemented in place but the grade has eroded around them exposing the concrete footing, causing a tripping hazard. The benches should be reset and the grade adjusted at each (image A11).

A9 _Cracked Walkway

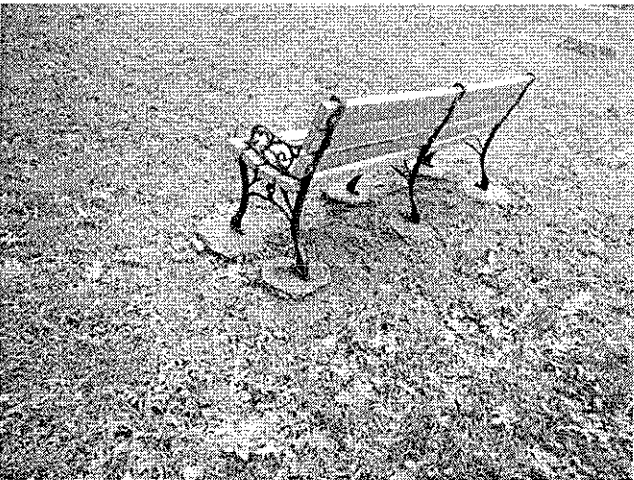
A11 _Exposed Footings

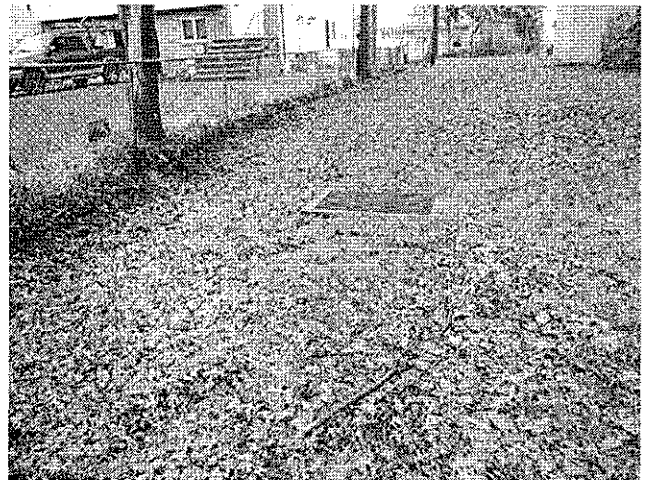
The rear of the property is mostly a grass area. There are some utilities and a storage shed here. Near to the back of the property is a storm drain inlet. This inlet is raised above grade and is also higher than the adjacent swale that collects water (image A12). The workings of the storm system were not investigated for this evaluation and would require input from the municipal engineer. Each of the inlets observed had a high level of water; it is possible that the system may need maintenance.

A12 _Raised Storm Drain Inlet

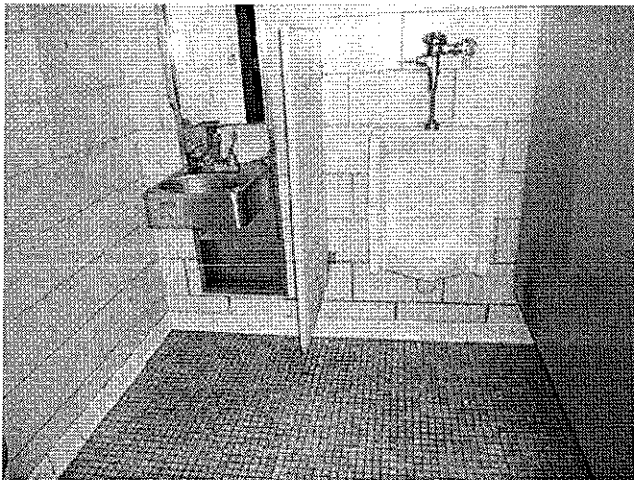
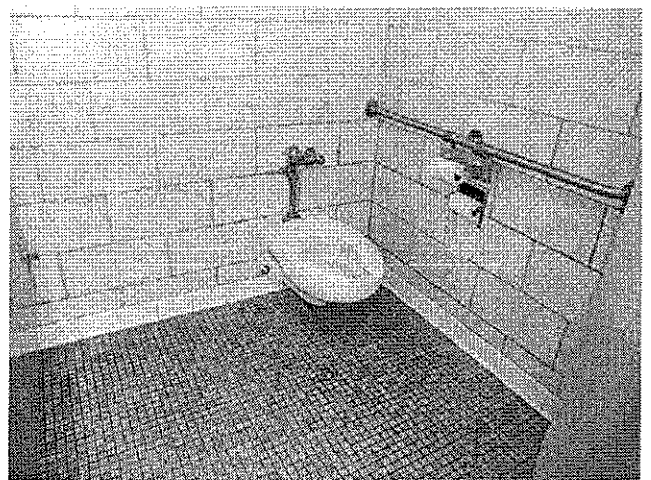
The ADA report noted deficiencies in the restrooms. These restrooms have glazed block walls, ceramic tile flooring and wall base, and ceiling tiles as noted previously. The walls and floors require grout cleaning and resealing to facilitate ease of daily cleaning. The wall base is damaged in areas and should be replaced. The ceilings need replacement due to their condition. The toilet stall partitions are rusting and require refinishing. As well, the engineering report recommends utilizing low-flow fixtures and replacing the toilets. (image A17, A18)

A17 _Men's Restroom

A18 _Men's Restroom

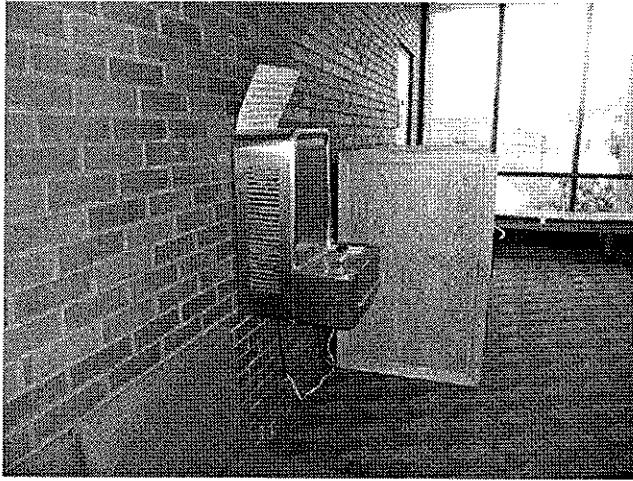
Access to the restrooms is another priority item per the ADA Guidelines. There are two restrooms located at the rear of the ground floor that are near complaint but require certain improvements. The sinks, faucets and accessories do not comply with the height and clearance requirements and should be replaced (image A17). There is a 60" x 60" toilet stall at each room (image A18). The toilet in each requires a raised seat to meet the minimum seat height of 17 inches. A grab bar is required at the back wall at each of these stalls. A compliant drinking fountain is located at each floor (image A19).

A19 _ Drinking Fountain

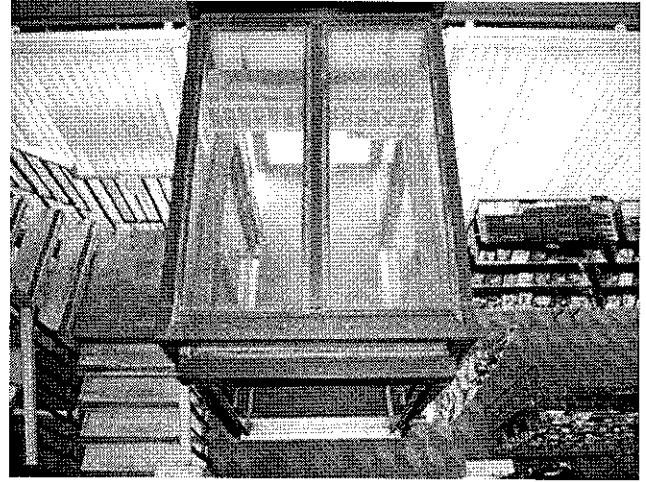
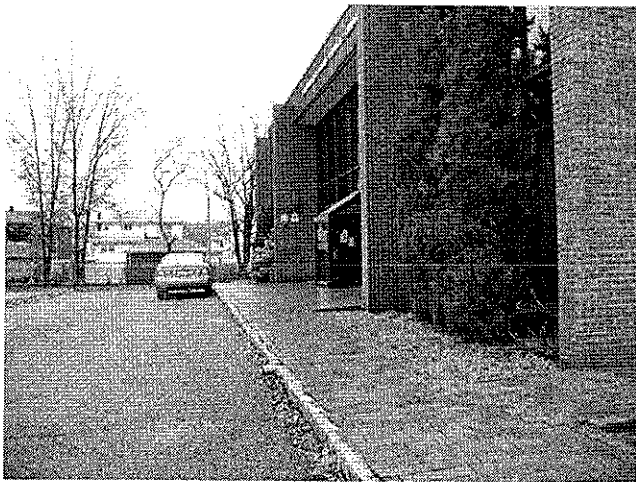
The entrance vestibule ideally should be reconfigured to alleviate the cramped sequence into the library and to remedy the hot/cold draft conditions for the employees and patrons at the circulation desk that is immediately adjacent to the vestibule door. Visitors tend to bottleneck at the entrance because the circulation desk is within 4 feet of the door and the security gates force are sandwiched between these two elements. With the exterior doors on an automatic operator, they tend to be held open at the same time creating a flow of unwanted winter/summer conditions directly into the workspace and service point at the desk. It is recommended that the vestibule be reconfigured to improve accessibility, patron movement and thermal comfort. (image A20, A23)

A20 _ Entrance Vestibule from Above

A23 _ Front Entrance

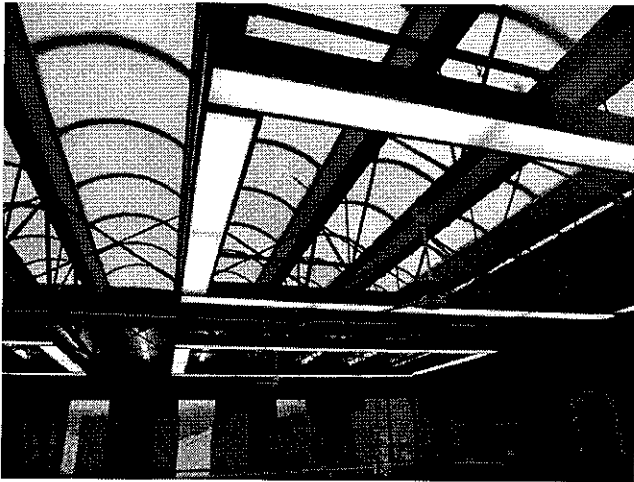
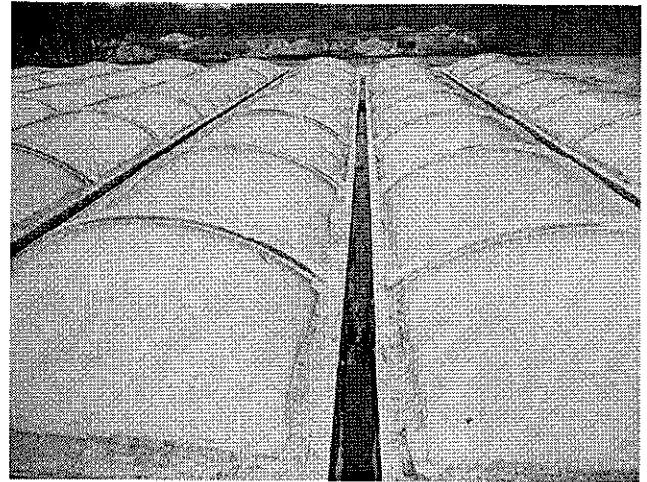
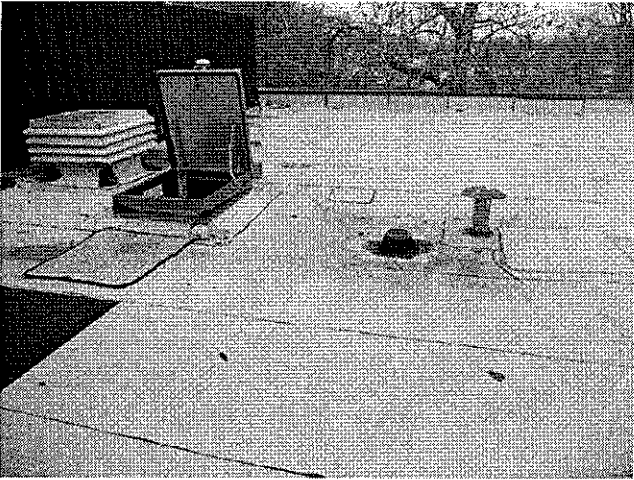
The cause of much of the second floor ceiling staining is the skylights. Leaks at these skylights have been patched throughout the years and the units themselves appear beyond their usable life. They should be replaced with a new, more energy efficient insulated type. As well, the roofing of the building has been patched a number of times. While it does not require immediate replacement, it should be planned to be replaced fully. (image A21, A22, A27)

A21 _ Skylights

A22 _ Skylights

A27 _ Roofing

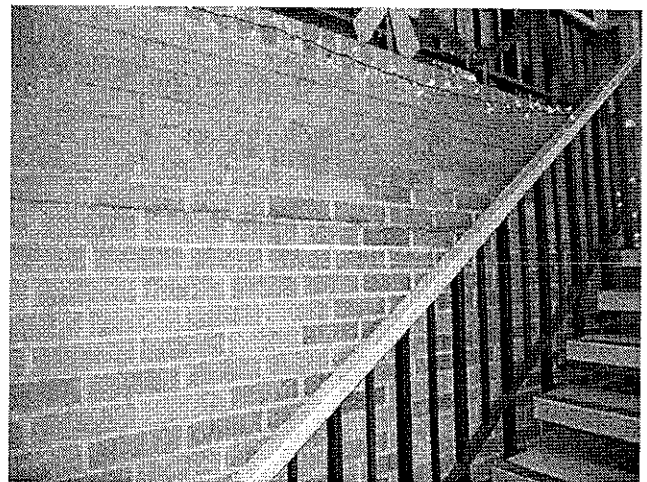
The building utilizes brick veneer as its exterior and most interior wall surfaces. This material is in good condition except for one interior open crack at the stair landing. The horizontal joint near to the second floor level has shifted. It appears that the joint can simply be opened, cleaned then caulked. (image A24)

A24 _ Interior Masonry at Stair Landing

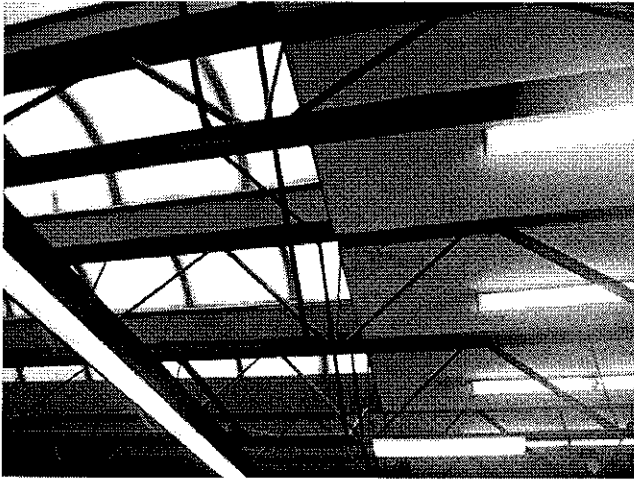
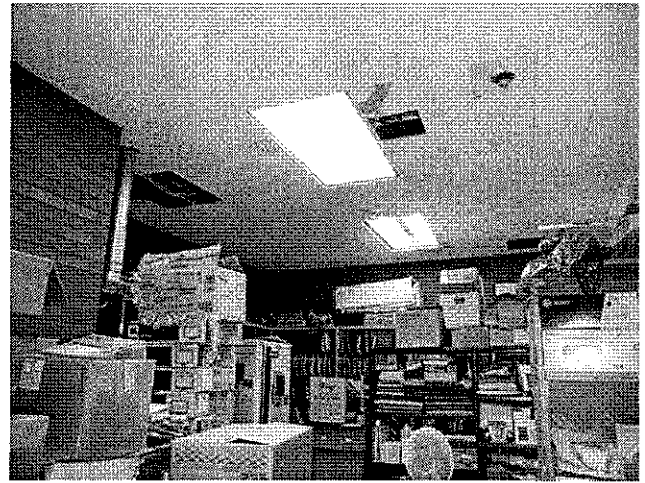
The flooring throughout the library appears to be in good condition. There is carpeting through the public spaces that was installed approximately 8 years ago. The ceilings are predominantly a 12'x12' acoustic concealed-spline tile. These tiles are in good condition at the ground floor but contain numerous water stains at the second floor spaces. Painting these tiles would impact their acoustic qualities and is not recommended. The ceiling tiles throughout the second floor should be replaced for this reason and for the HVAC work recommended at the Engineering Assessment. (image A25, A26)

A25 _ Skylight and Ceiling Tile

A26 _ Ceiling Tile at 2nd Floor

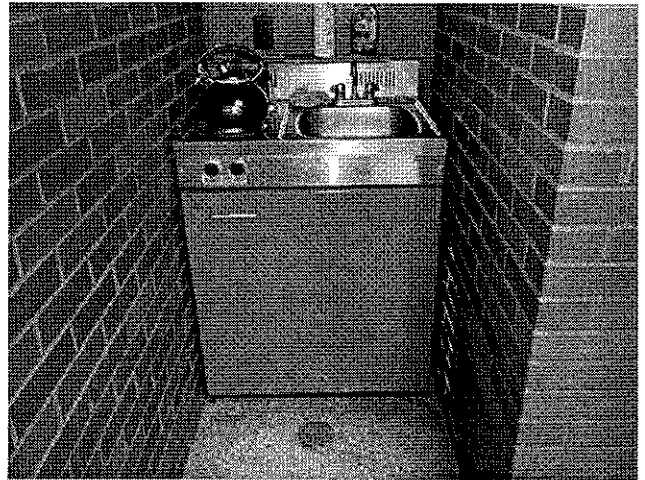
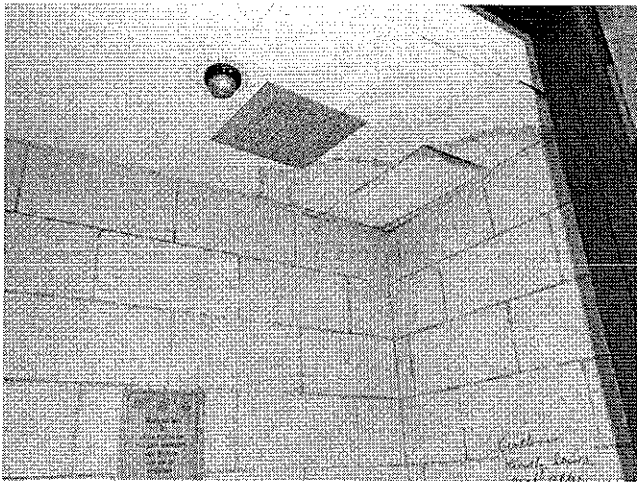
The staff lounge has a small kitchenette unit with a sink and stove. The sink does not have hot water and the stove pilot light is apparently broken. These units require servicing. The lounge has a small restroom that requires ceiling tile replacement, glazed-block wall and ceramic floor tile cleaning, and replacement of the ceramic wall base. (image A28, A29)

A28 _ Staff Lounge

A29 _ Staff Lounge Lav

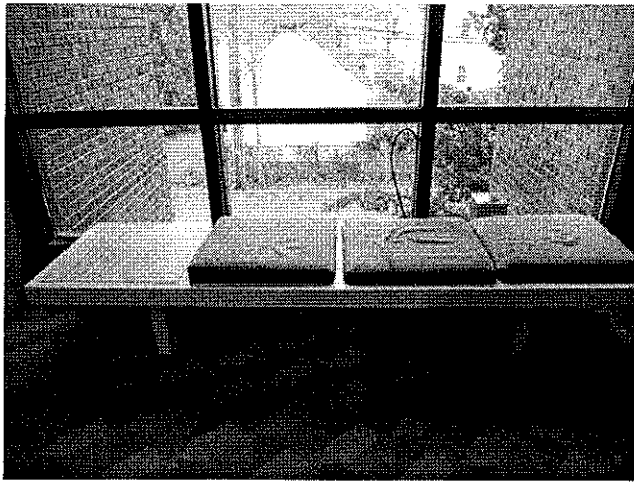
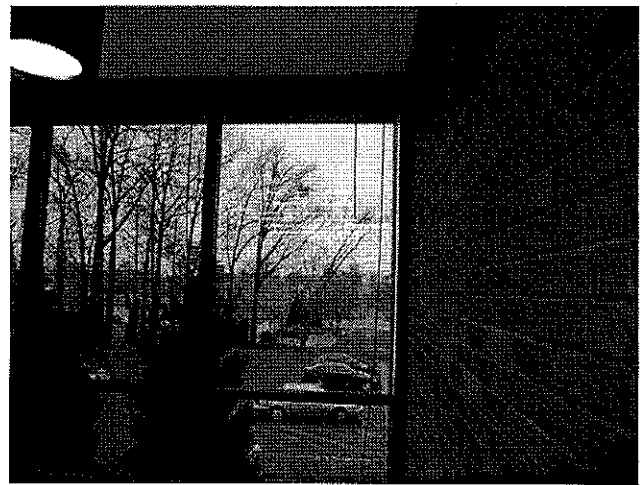
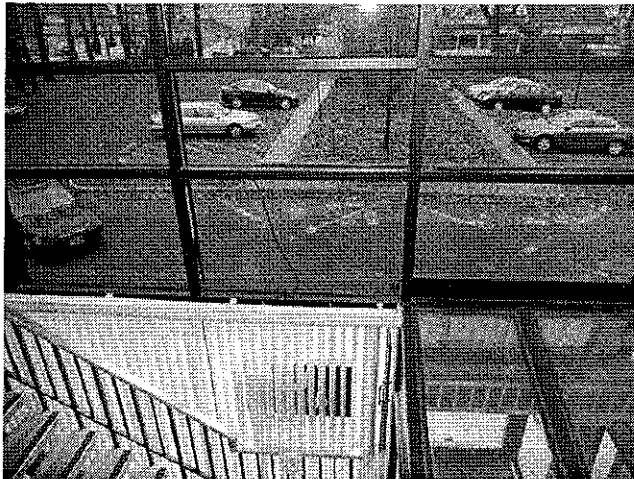
Throughout the library it was noticed that the window gaskets are separating from the frames. The existing glass is original to the building and is insulated double-pane type. There appears to be a significant sun glare issue at the front westerly facing wall. A tinted film was applied to the upper sections that helps some but darkens the space and makes the building seem less inviting from the exterior. We recommend replacement of the glass within the existing frames with a more efficient, high-performance tinted glass. Installation of a commercial shade at the front wall, such as Mechoshade, would give better control of the daylight and sun glare. (image A31, A32, A33)

A31 _Window Gasket at South Side

A32 _Window Gasket at Front

A33 _Window Gasket at Front

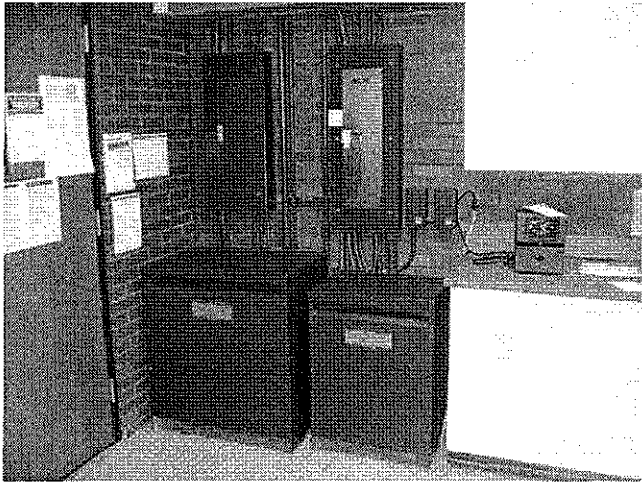
E1_

The transformers located in the staff room are obtrusive (Image E1). The transformer should be installed in a new closet to conceal the units. The closet should include a door that provides a minimum of 3 feet clearance in front of unit. Closet is recommended to be provided with an exhaust fan. A 3 foot clearance should be provided at all electrical panels (Image E2).

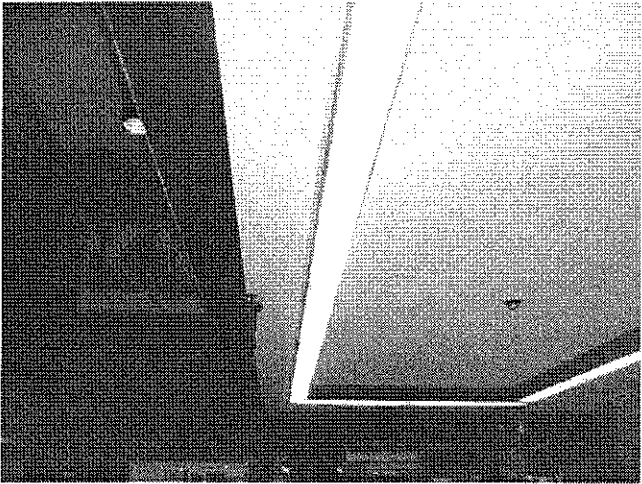
E3_

The lighting was upgraded four years ago and is of today's standard. The existing lighting is dated and a lighting fixture upgrade could do a lot for the appearance of the library (Image E3). The existing parking lot pole light controls are recommended to be evaluated and repaired as required.
