ELMWOOD PARK FREE PUBLIC LIBRARY

CAPITAL PLAN

January 2012 - December 2016

Executive Summary

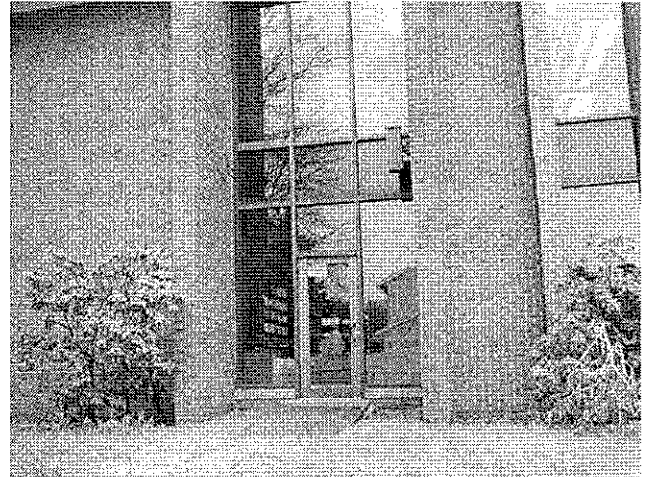
A10 _Sloped Walk

Along the North side the concrete walk that leads to Lee Street at the rear, has one area that is cracked and in need of repair but overall it is in good condition (image A9). This side also has an emergency exit door with a sloped brick walk (image A10). There are benches located in the grass area. These are cemented in place but the grade has eroded around them exposing the concrete footing, causing a tripping hazard. The benches should be reset and the grade adjusted at each (image A11).
